Analysis of Defficiencies in Building Structure as a Contributing Factor to Building Failure

Mohamad Budi Hartono[a]*, Anik Ratnaningsih[b], Dewi Junita Koesoemawati[c]

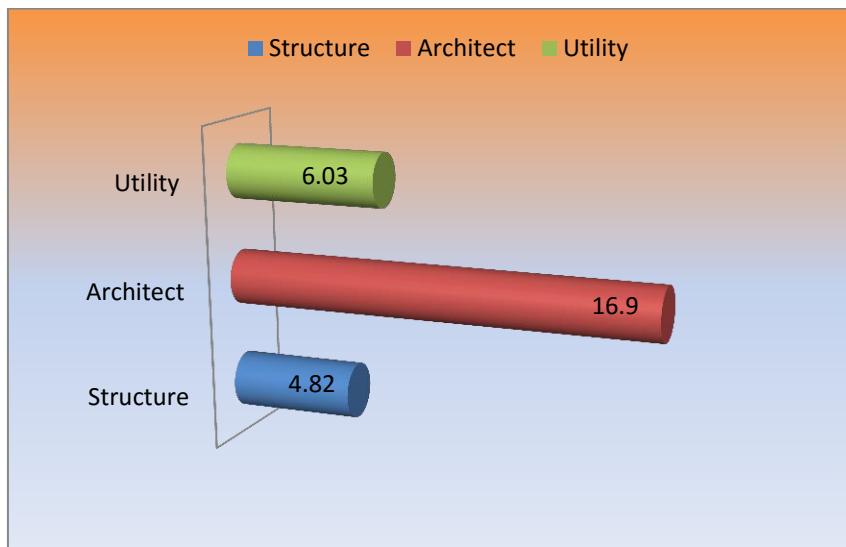
Figure 6: Example graph of percentage of damage to buildings of staff buildings

Figure 6 above is an example of the results of the calculation of the percentage of damage for staffing buildings. It can be seen that the average value of the percentage of damage to each structural element is ≤ 30%, which means that the condition of the staffing building is slightly damaged.

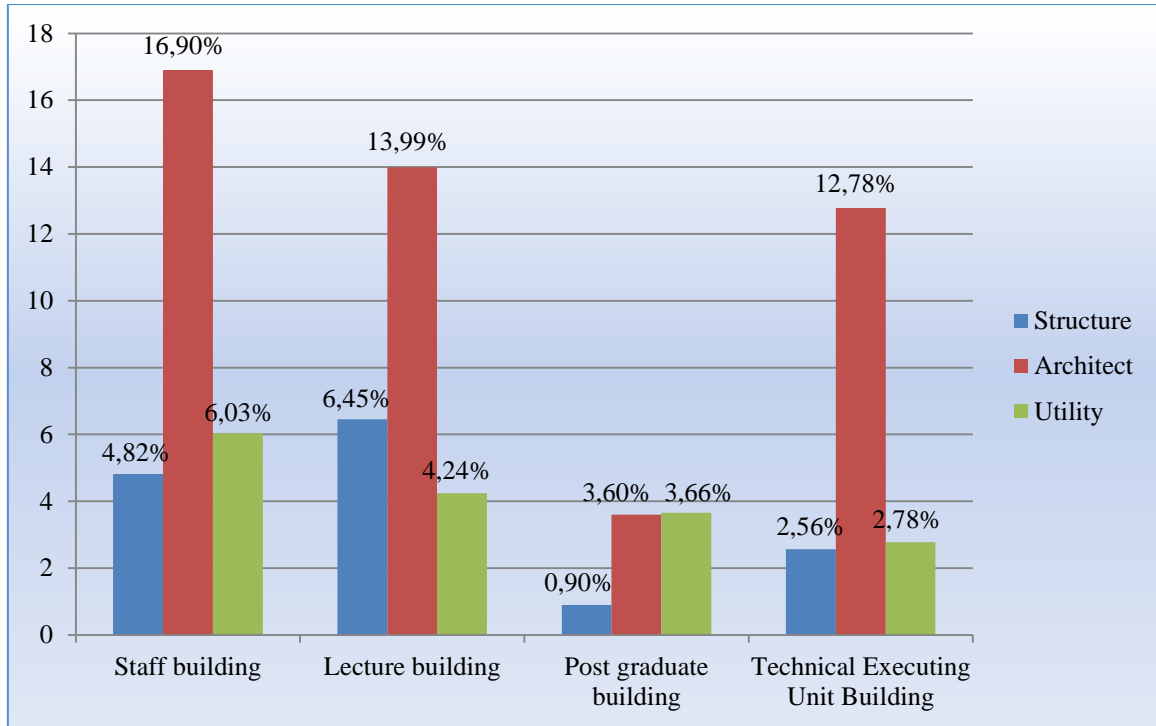
Figure 7: Recapitulation of the percentage of damage to 4 buildings

Figure 7 above is a recapitulation of the results of the calculation of the percentage of damage in the four main buildings of the IAIN campus building (staff building, lecture buildings, post graduate building and Technical Executing Unit Building) which is over 10 years old.

From the results of data analysis, the damage level category in the four main buildings of the IAIN Jember campus is in the category of minor damage, so that only repairs are needed on the architectural elements and routine maintenance, as shown in table 4.

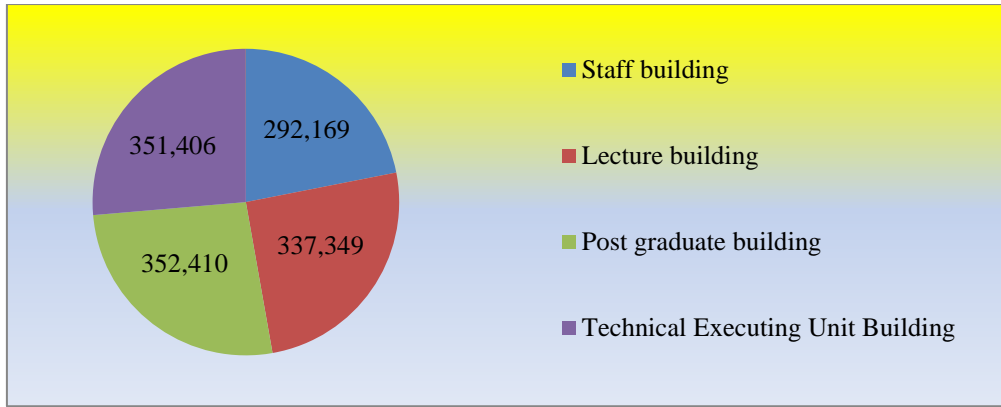
Figure 8: Recapitulation of the average compressive strength value of 4 buildings.

From the resulting calculations, it can be seen that the lowest average compressive strength is found in the staff building at 292,169 kg / cm^2. This value is still above the value required by Indonesian government regulations for high-rise buildings of 225 kg / cm^2 [15].
